# PLAT OF SURVEY

## BOUNDARY SPLIT SURVEY

A Parcel of Land Situated In The Northeast Quarter Of Section 17, Town 6 North, Range 4 East,  
North & East Of The First Principal Meridian And Base Line,  
Springfield Township, Williams County, Ohio

Prepared For: Pine Grove Mennonite Church

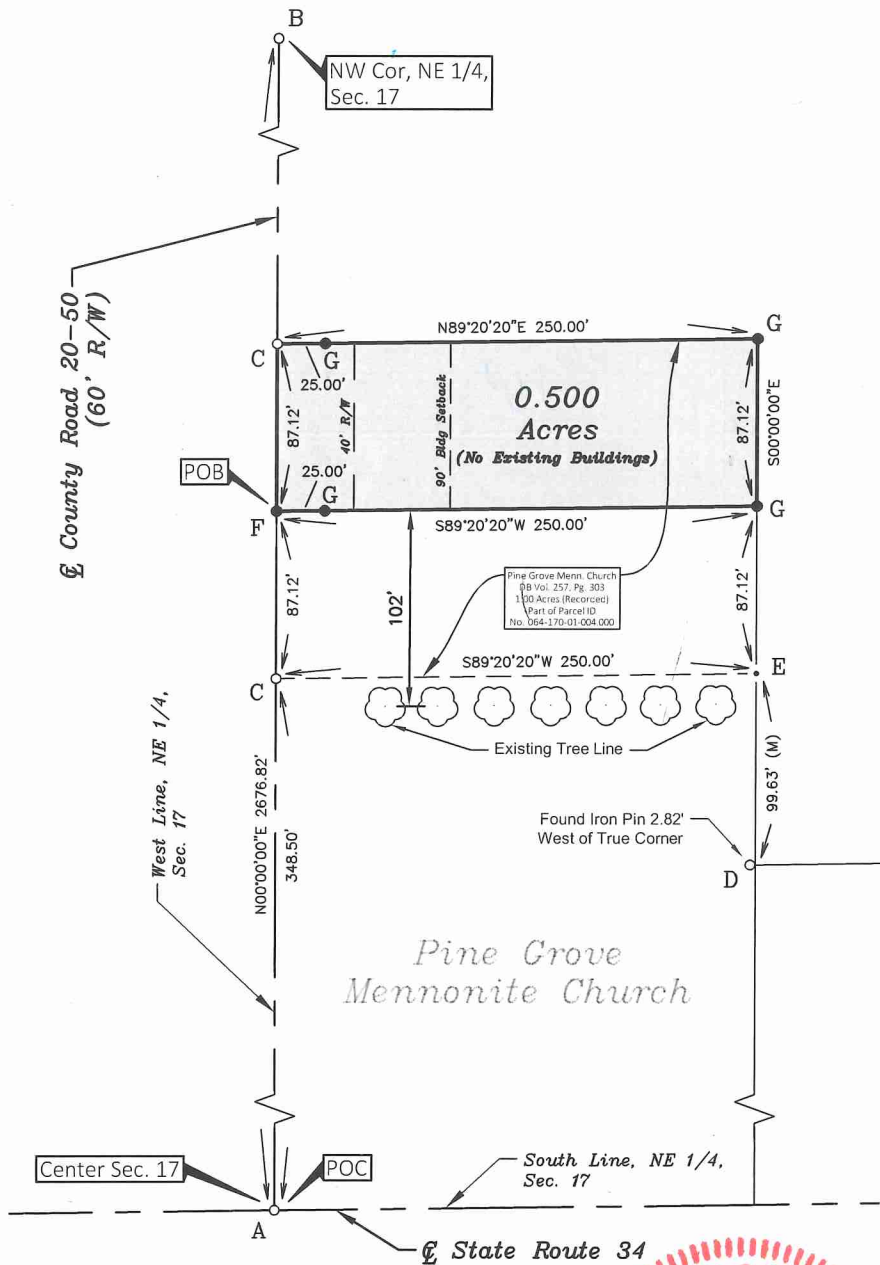
- A. Found MAG Nail
- B. Found Iron Pin
- C. Found Railroad Spike (3" deep)
- D. Found 3/4" Smooth Iron Pin
- E. Point Established
- F. Set Railroad Spike
- G. Set 5/8" Rebar w/ ID Cap

Rebars called for as Set are 5/8" Dia., 30" long, set flush with ground (unless otherwise noted) and capped with yellow plastic cap inscribed "KRUEGER/PS 8572".

The subject property is an agricultural field and no lines of occupation exist.

The bearings shown hereon are based on an assumed bearing and are for the sole purpose of showing angular measurement.
